US TRANSCOM JDDE Program

Full-Scale Trafficability Testing of Prototype Submersible Matting Systems

October 2023

Final report

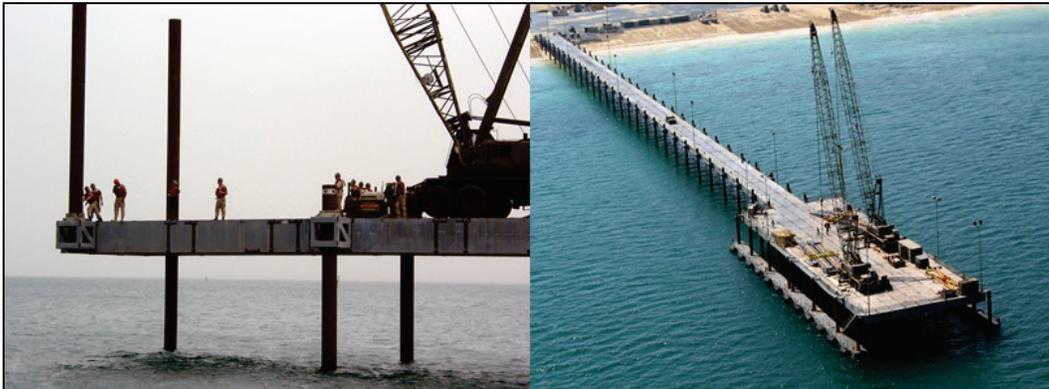
The Elevated Causeway system (ELCAS), shown in Figure 2, provides an expeditionary Roll-On/Roll-Off (RO/RO)-capable pier at a beach. Like a commercial harbor, the pier extends beyond the beach into the water, allowing vessels to unload cargo. The elevated causeway allows unloading of sea-going vessels without lighterage.

Figure 2. Elevated Causeway system (ELCAS) piles being installed (*left*). Completed ELCAS (*right*).

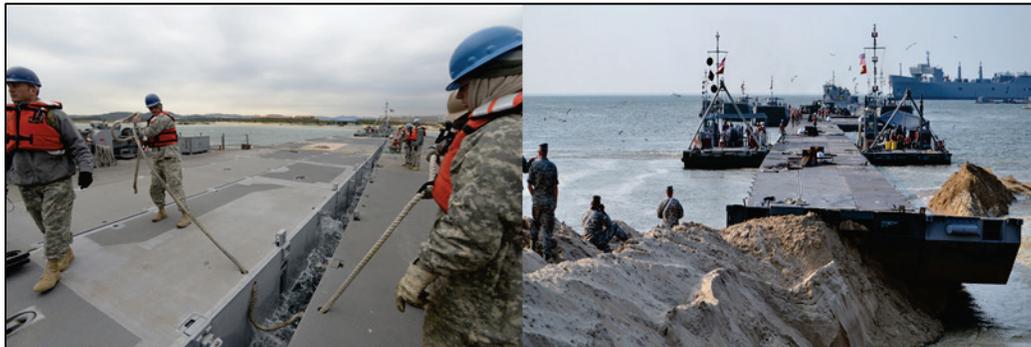
The Trident pier system, shown in Figure 3, provides an expeditionary RO/RO-capable floating pier at a beach. The pier may be deployed to the construction site either by road or by ship.

Figure 3. Trident pier being assembled offshore (*left*) and landed at prepared site (*right*).

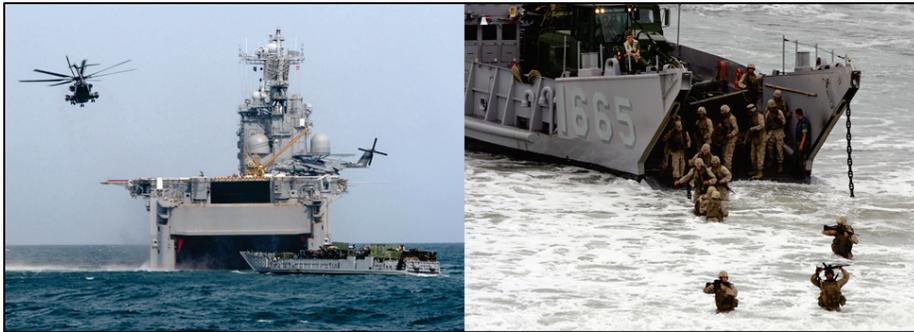
The Army and Navy Landing Craft Utility (LCU), shown in Figure 4, is capable of intratheatre transport of combat vehicles and sustainment cargo. It is ideally suited for discharge and backload from dock landing ships (e.g., landing ship docks, landing helicopter docks, and landing helicopter assaults, and the Large Medium-Speed RO/RO [LMSR]).

The LCU transports the heavy equipment and supplies ashore while able to operate independently in support of littoral maneuver, security cooperation, noncombatant evacuation, foreign humanitarian assistance, and disaster relief operations. LCUs have both bow and stern ramps for onload and offload and can conduct sustained operations at sea for up to 10 days.

Figure 4. A Landing Craft Utility (LCU) pulls away from a helicopter landing dock (*left*). Marines discharge from LCU into the swash zone (*right*).

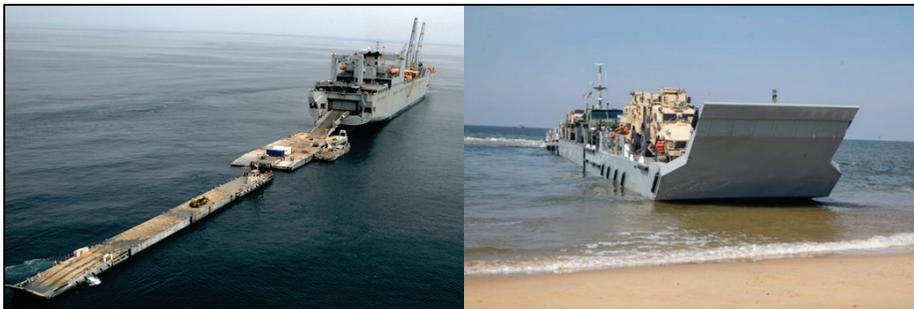
The Improved Navy Lighterage System (INLS), shown in Figure 5, is comprised of powered and nonpowered barge-like modular platforms that are assembled into multiple configurations to satisfy mission requirements. These Causeway Ferries (CFs) are designed to discharge from the Maritime Prepositioning Force and Military Sealift Command when port facilities are damaged, inadequate, or unavailable. The RO/RO Discharge Facility is made up of nine nonpowered causeway sections and provides the at-sea Maritime Prepositioning Ship interface capability. CFs can also enter well decks of amphibious warfare ships to provide additional options to support ship-to-shore movement.

Figure 5. An assembled Improved Navy Lighterage System (INLS) and loaded from a Large Medium-Speed RO/RO (LMSR (*left*). A Causeway Ferry (CF) with powered barge and unpowered landing barge preparing to discharge vehicles (*right*).

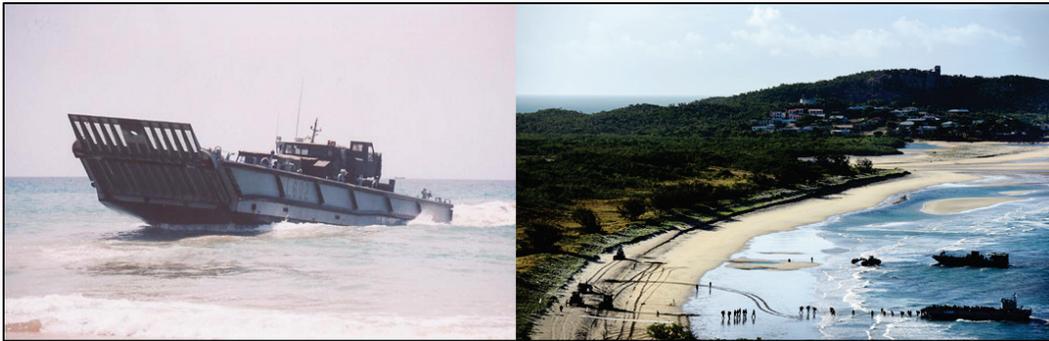
The Landing Craft Mechanized (LCM)-8, shown in Figure 6, is a rugged, steel, displacement vessel used to transport cargo, troops, and vehicles from ship to shore or in retrograde movement. It is designed for use in rough or exposed waters, operated through breakers, and grounded on the beach and debeaches under its own power. LCMs have a bow ramp for onload and offload and can transport 100 passengers or 60 tons of cargo.

Figure 6. A Landing Craft Mechanized (LCM) beaches itself to discharge vehicles and personnel (*left*). Marines discharge from LCMs (*right*).

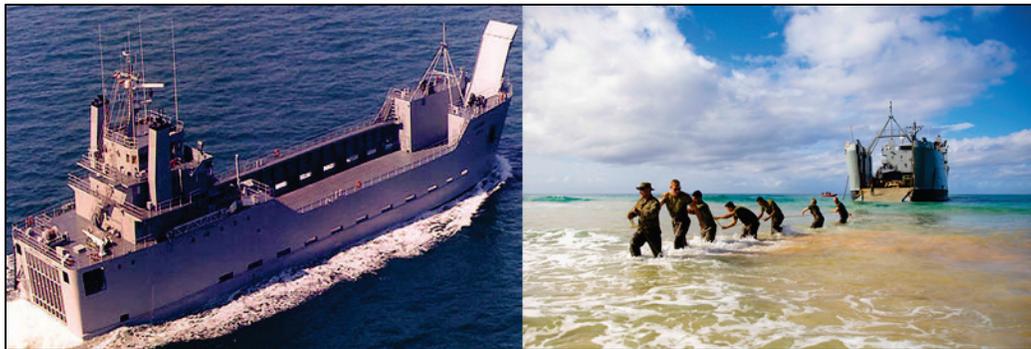
The Army Logistics Support Vessel (LSV), shown in Figure 7, has the capabilities of intratheatre unit deployment or relocation and the transport of supplies to support sustainment to remote, undeveloped areas along coastlines and inland waterways. The LSV has a payload of 2,000 tons and can assist in off-loading and backloading ships in a RO/RO operation. The bow and stern ramps can be used for RO/RO operations, and a bow thruster assists in docking and undocking.

Figure 7. An army unloaded Logistics Support Vessel (LSV) underway (*left*). Marines pulling a vehicle mat off the deck of an LSV to support vehicle discharge operations.

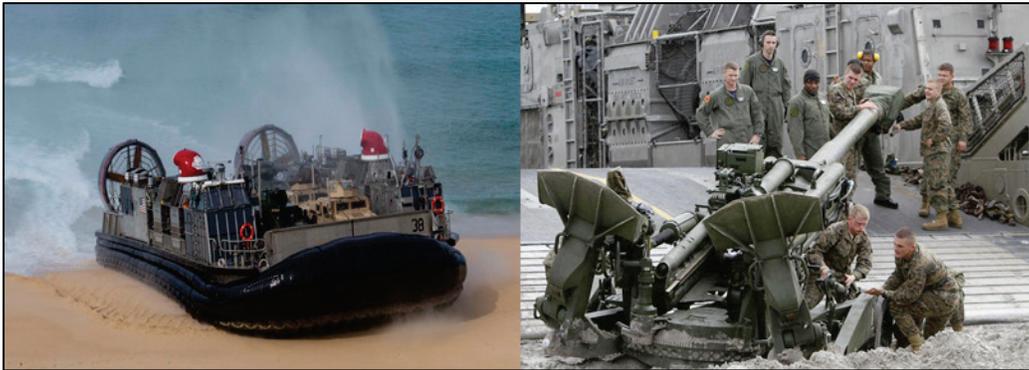
The Landing Craft Air Cushioned (LCAC), shown in Figure 8, is assumed not to be compatible with the SUBMAT system.

Figure 8. A Landing Craft Air Cushioned (LCAC) transiting the wet/dry interface (*left*). Marines struggle to discharge artillery in the swash zone from an LCAC (*right*).

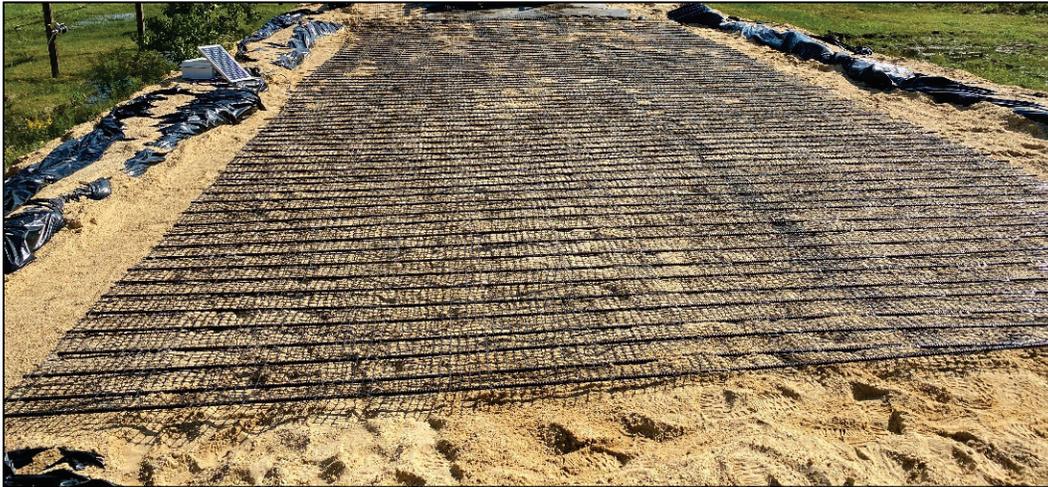
Rebar provides durability and spreads the wheel loads over a wide area to reduce rutting. The rebar used was AIT Composites (AIT Composites; Brewer, Maine) GBar #4 basalt rebar in 20 ft bar lengths with a yield strength of 154.6 ksi. The rebar was woven into a row of geogrid every sixth cell along the length of the mat and woven through every sixth cell across as shown in Figure 17. The spacing of six cells is approximately 7 in. on center. For this test, the rebar was woven into the mat by hand and tested under the load of military vehicles at the GVTSTF. The deployed prototype can be seen in Figure 18.

Figure 18. Deployed RGM.

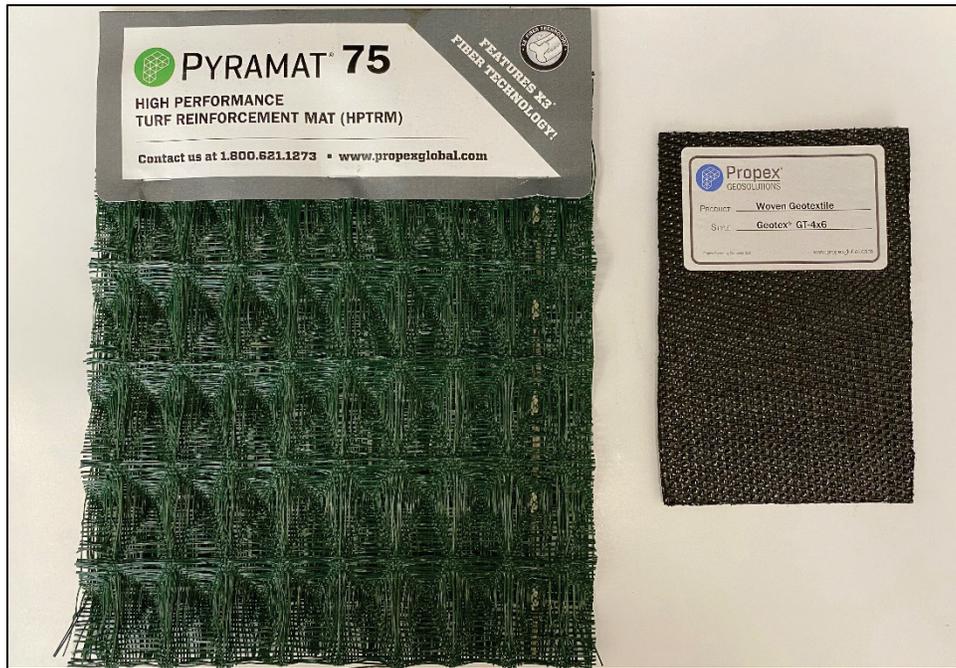
Figure 19. PYRAMAT (*left*) and geotextile (*right*) materials that constitute the PYRACELL Road Building System (PRBS) layers.

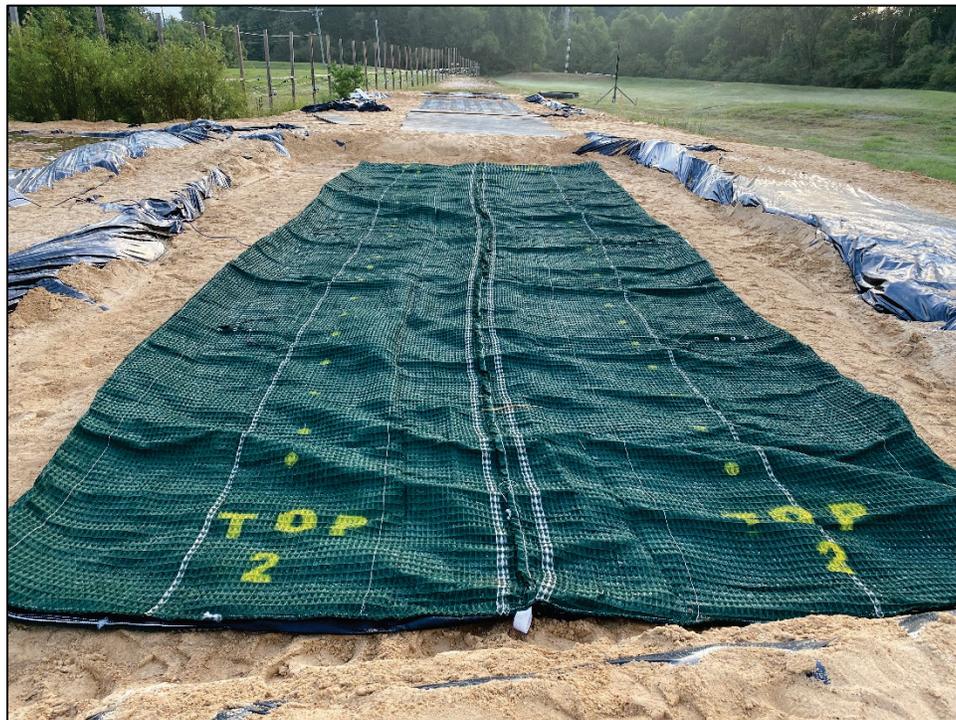
The PYRACELL Road Building System (PRBS) is a novel combination of commercial technologies for defense mobility purposes. It is composed of GEOTEX (Propex Geosolutions; Chattanooga, Tennessee) 4 × 6 polypropylene geotextile with heavy woven serrated yarns, sewn into a rectangular mattress protected by an outer layer of PYRAMAT (Propex Geosolutions; Chattanooga, Tennessee), a 3D, lofty, polypropylene geotextile woven into a uniform configuration of resilient pyramid-like projections. The geotextile material and PYRAMAT material are shown in Figure 19. The seam strength of the sewing operation is greater than the strength of the geotextile. In October 2021, two slightly different PYRACELL mattress prototypes were tested at ERDC to determine performance under military vehicle wheel loading. Both prototypes were constructed by first sewing a 1 ft high by 7.5 ft wide × 40 ft long rectangular mattress with a longitudinal line of 12 in. long internal vertical braces located 3.5 ft from the mattress edge. The 12 in. long internal vertical braces were located on either a 1.5, 2.5, or 5 ft spacing. In addition, the mattress had three fill sleeves sized to accommodate a 6 in. diameter fill pipe. To complete the construction of the prototype to be tested, two of these rectangular mattresses were sewn together to form the 15 ft wide prototype. The result for the trafficking test was two 1 ft high × 15 ft wide × 40 ft long PRBS prototypes. Photographs of the two PRBS prototypes are shown in Figure 20 and Figure 21.

Figure 20. PRBS 1 rolled out and ready to be filled in test pit.

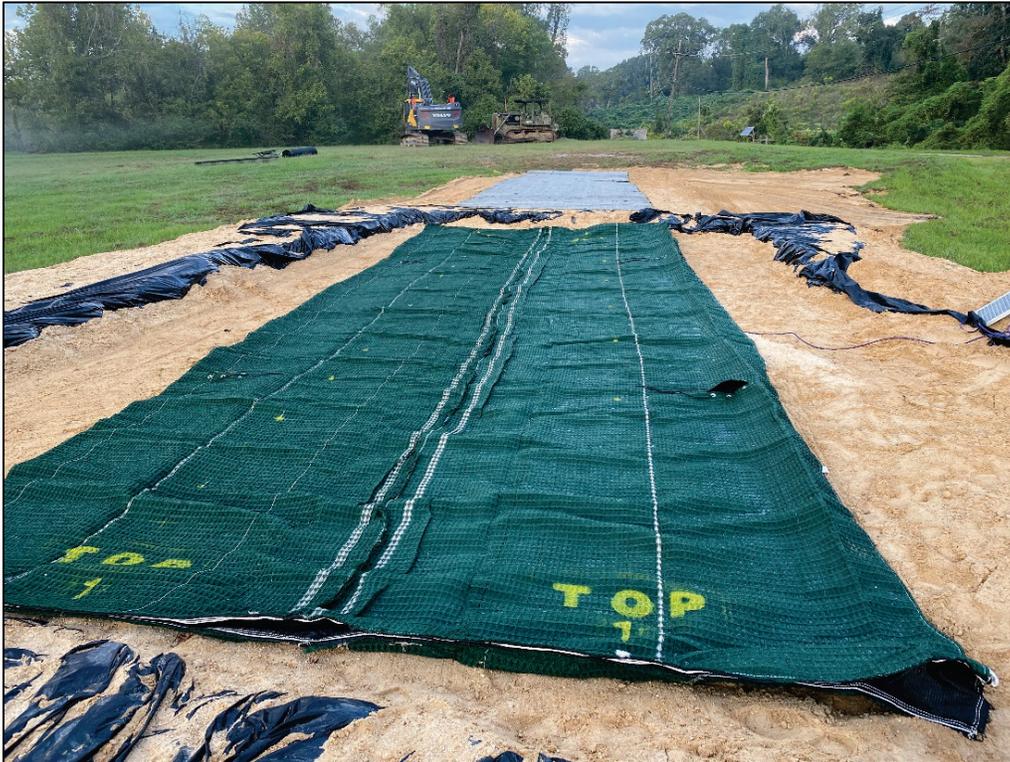
Figure 21. PRBS 2 rolled out and ready to be filled in test pit.

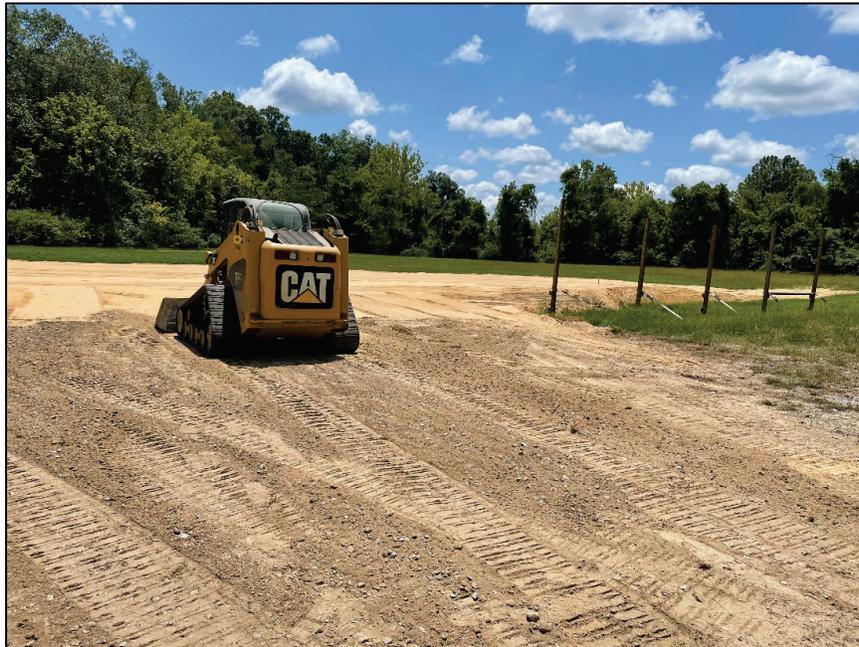
The test section was constructed using an excavator and a skid steer to place the sand at the site into a roadway that was approximately 240 ft long, 30 ft wide, and 6 ft high. Once the sand was roughly leveled, three pits were dug along the length of the sand subgrade. Each pit was 40 ft long, 20 ft wide, and 2 ft deep. The pits were lined with a plastic lining to allow them to retain water. Once lined, the pits were refilled with the original sand, and an earth pressure cell (EPC) was installed in each of the traffic pits approximately 1 in. below the surface in the line of the north wheel path of the traffic. The pits were distributed such that each pit was approximately 30 ft from the next pit. Transition ramps of AM2 mat were placed over the sand subgrade to support traffic between the prototype matting systems.

Figure 22. Leveling sand at test site with a compact track loader.

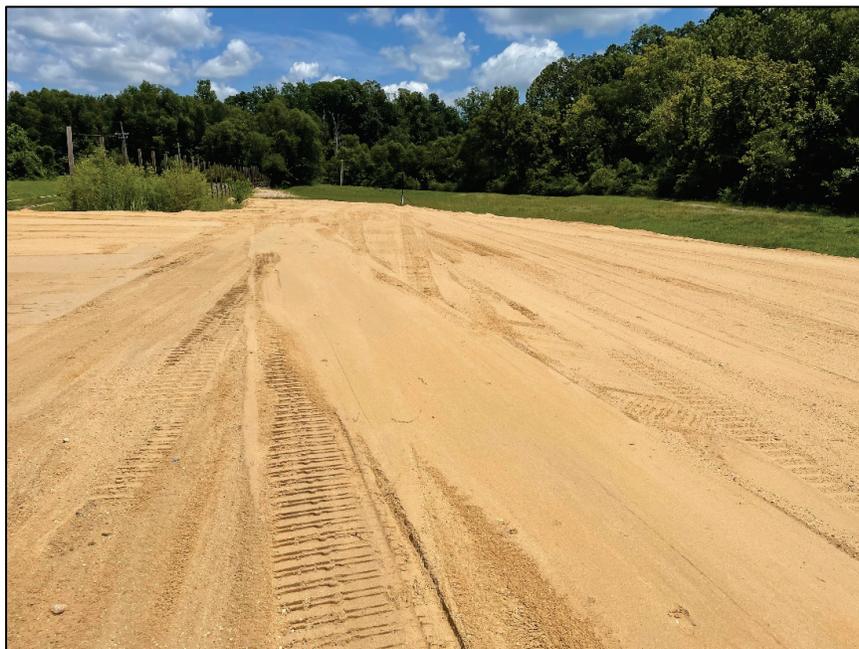
Figure 23. Test site prior to excavating pits for test-article installation.

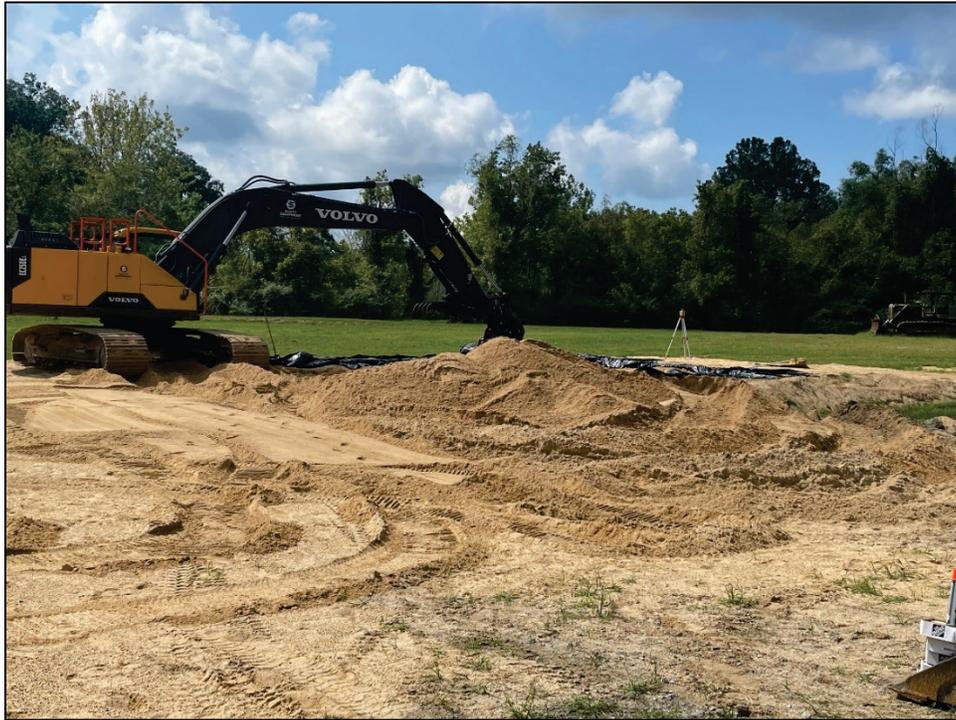
Figure 24. Excavating sand pits for test-article installation.

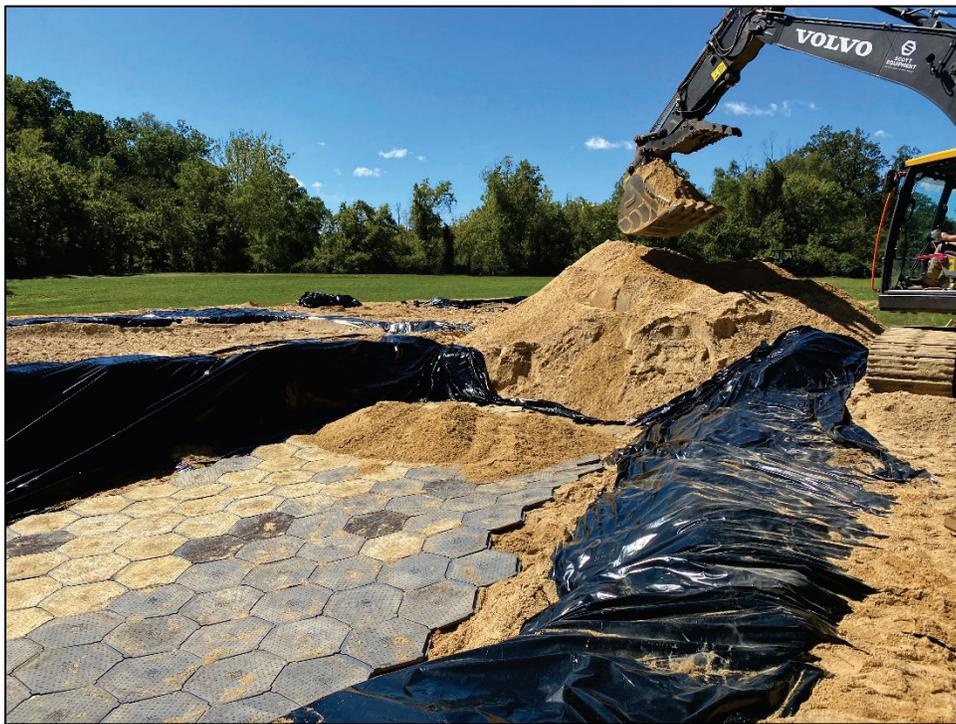
Figure 25. Excavated dredge pit, lined with plastic and floored with hex mat to prevent pump from sucking up liner.

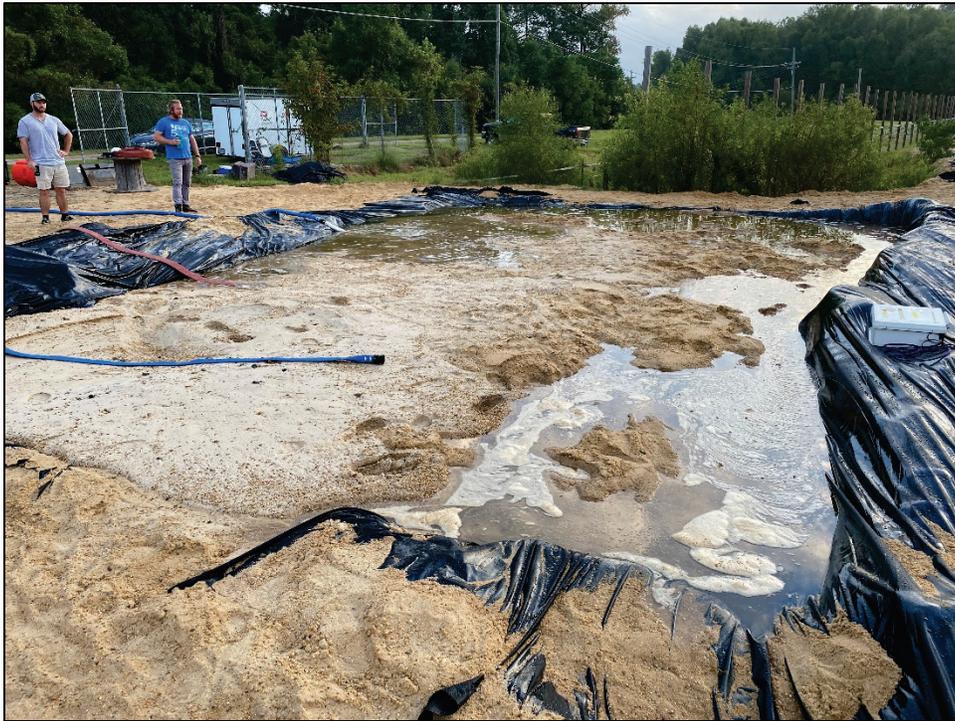
Figure 26. Dredge pit filled with sand and saturated with water to make a slurry fill for the PRBS mats.

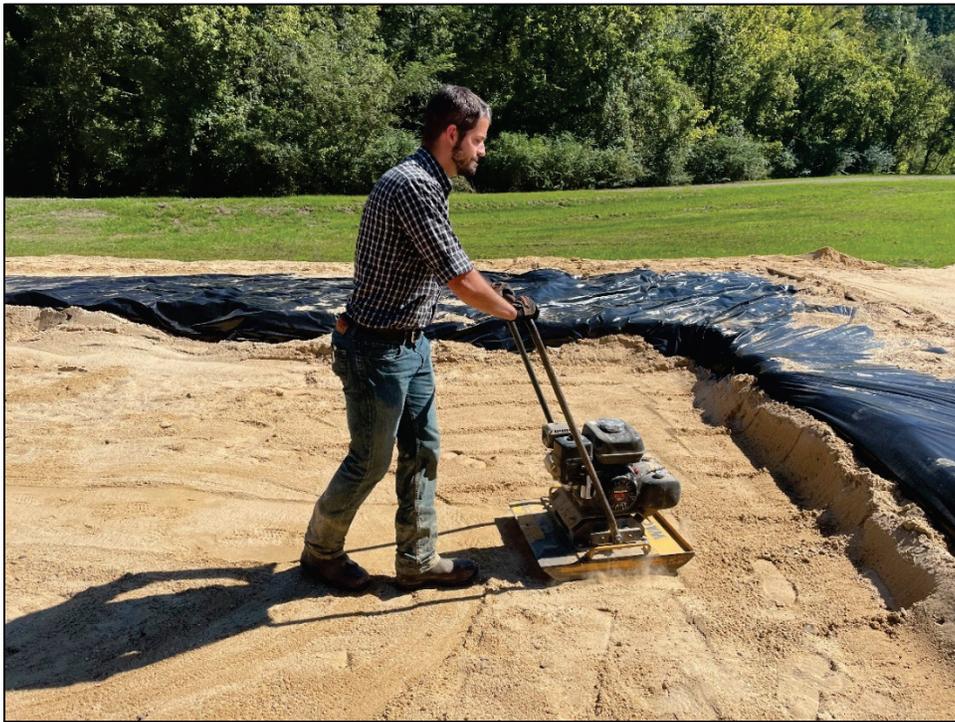
Figure 27. Compacting loose sand prior to test-article installation.

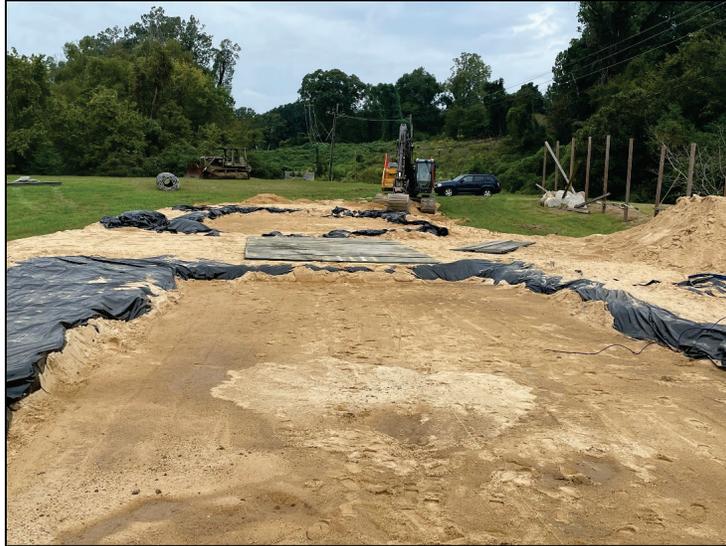
Each matting system was deployed within a traffic pit such that the surface of the matting system was approximately flush with the transition ramps between each traffic pit. On the outer edges of the test section, Supatrac (Mojo Rental; Manheim, Pennsylvania) ramps were placed over the sand subgrade. Figure 22 through Figure 28 show the construction of the sand road and test pits.

Figure 28. Completed test pits prior to test-article installation.

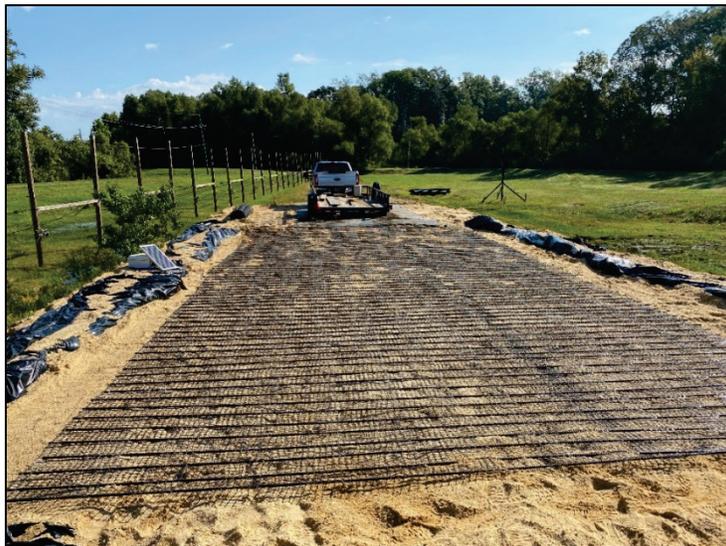
The RGM was installed by pulling the rolled-up mat to the traffic pit via a trailer. Once the mat was near the pit, a team of four lifted the mat off the trailer and placed it onto the ground near the east end of the traffic pit. The team then unrolled the mat across the 40 ft long pit and anchored it into place by using a sledgehammer to drive steel rebar anchors over the basaltic rebar reinforcements. The deployed RGM is shown in Figure 29.

Figure 29. RGM just after unrolling onto the sand test section.

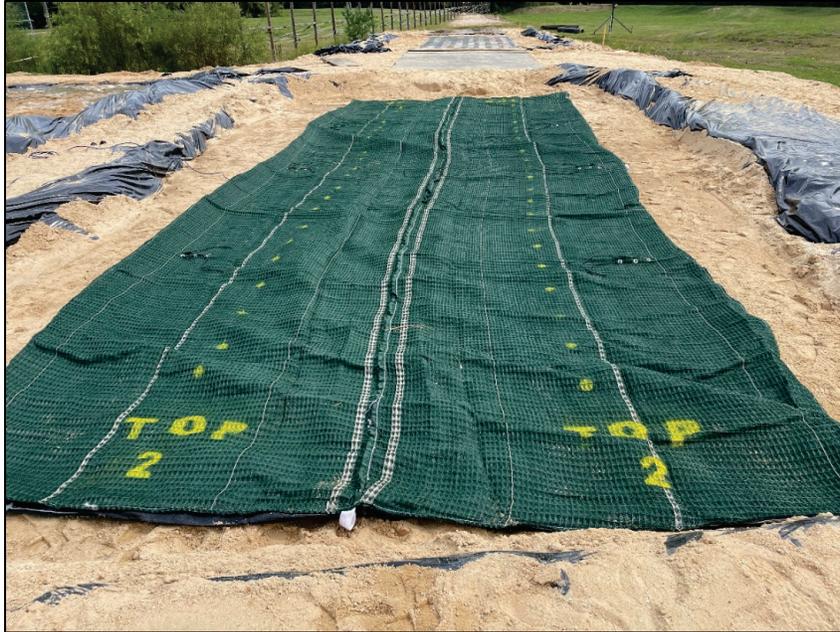
The PRBS matting prototypes were taken from shipping pallets, unrolled, and carried by the corners by a team of four. Each mat prototype was placed into its own traffic pit and was ready to be filled by sand pumped from the dredge pit. A picture of PRBS 1 in the central trafficking pit is shown in Figure 30.

Figure 30. PRBS 1 after unrolling onto sand test section.

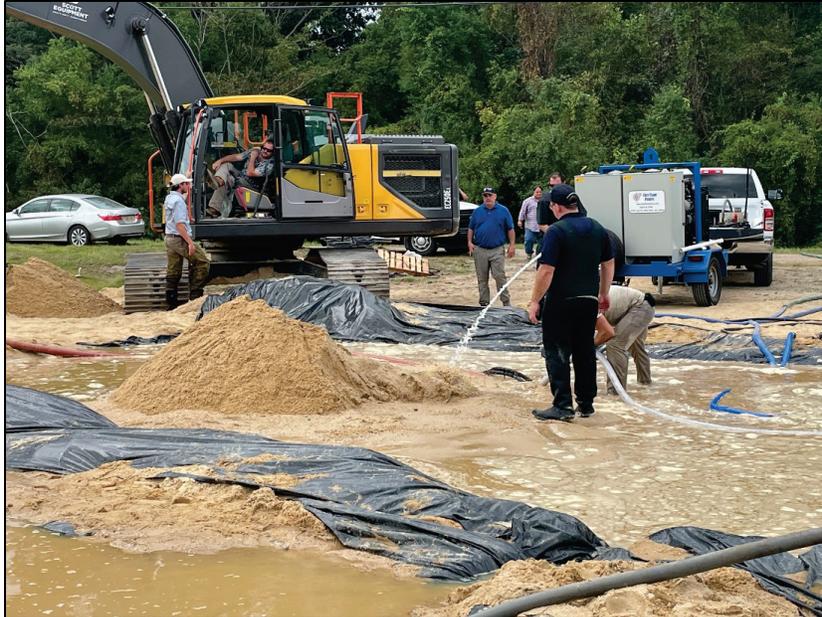
For the filling of the PRBS mats, Fast Flow Pumps, LLC, demonstrated the capability of its 3 in. Ductile Iron Twin Motor Pump (Fast Flow Pumps LLC; Moss Point, Mississippi). The pump was desirable for the compact design, 21 in. × 10 in. × 12 in., and high volumetric flow rate of up to 600 gpm. While the pump itself is physically small and relatively lightweight, 78 lbf, it requires a hydraulic power unit (HPU), which has a much larger logistical footprint. A vehicle with hydraulics (e.g., a skid steer or front-end loader) could be used to supply the hydraulic power; however, the effectiveness depends on the hydraulic capacity of the equipment. The filling process using the commercial pump is shown in Figure 31, Figure 32, and Figure 33.

pieces also tended to accumulate, causing slugs to form in the hose as well as choking the pump at the impellor. After a day of attempting to fill the PRBS, only approximately an eighth of the mat was filled. Thus, this pump was deemed unsatisfactory for this application, and a more appropriate pumping system for field deployment of the PRBS was required.

Figure 31. Using the Fast-Flow Pumps system to dredge sand for filling PRBS.

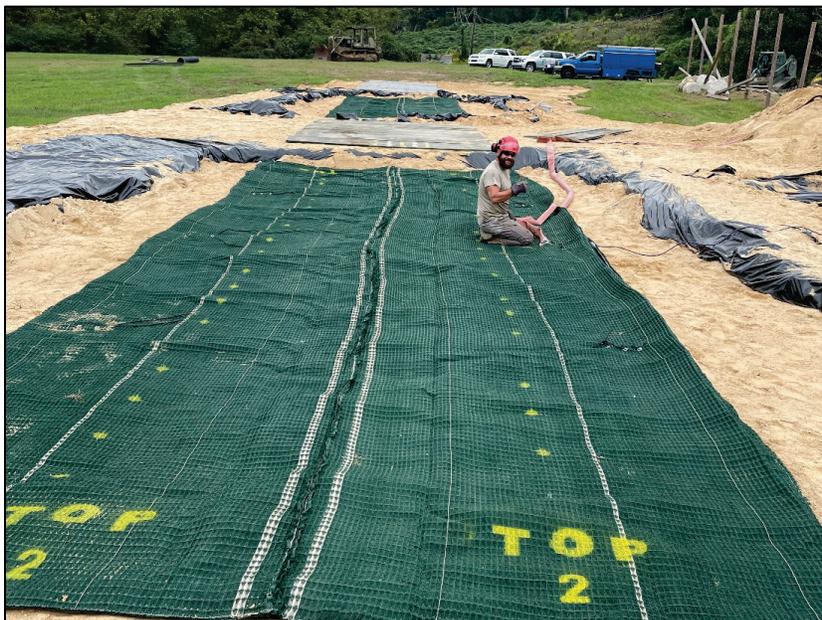
Figure 32. PRBS ready for filling with Fast-Flow Pump system.

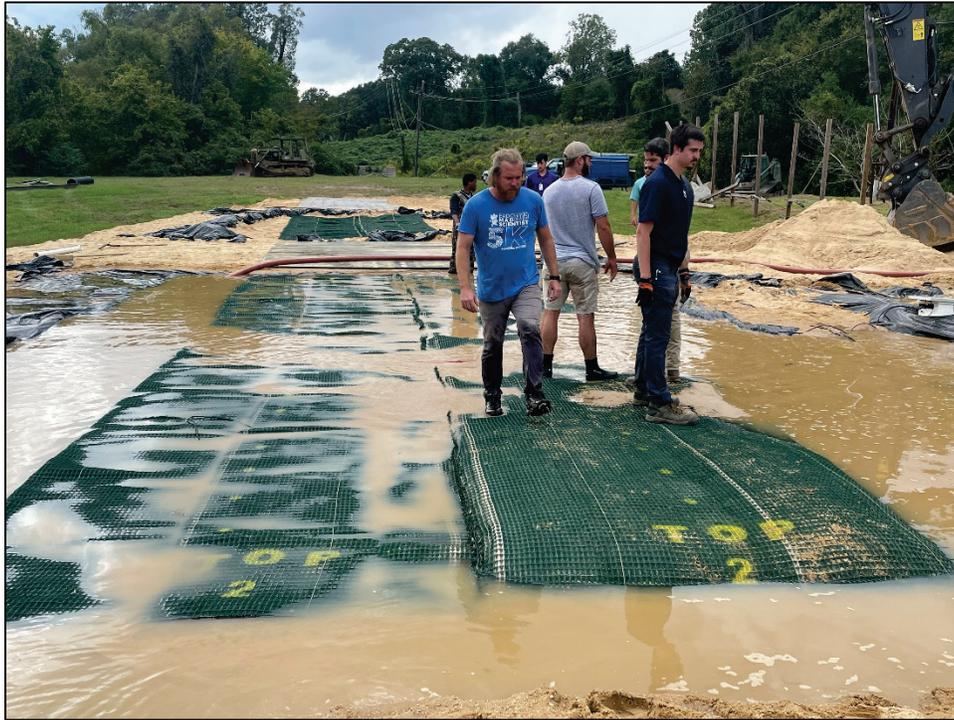
Figure 33. PRBS while filling with the Fast-Flow Pumps system.

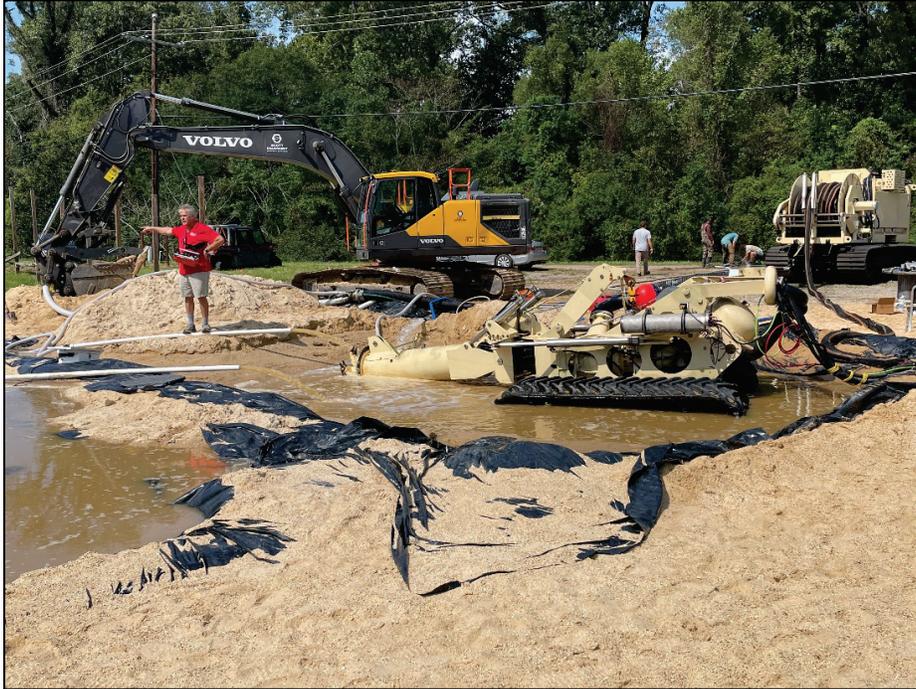
The following day, the research team utilized the Mini Robotic Submersible–Dredge (MRS-D) to fill the PRBS. The MRS-D system is shown in Figure 34. Like the previous pump, the MRS-D system requires a substantial HPU, but the system comes with a mobile HPU. Although the MRS-D proved capable of filling the PRBS, the capacity of the system was simply too powerful for the task. The system was running on the lowest possible settings, but the pressure of the dredged material going into the PRBS caused the strapping within the PRBS to fail with an audible popping during the filling operation. The internal strapping of the PRBS was meant to confine the shape of the PRBS to ensure a relatively flat surface rather than a pillowed or ballooned shape whereby too much material had settled in a local area of the PRBS. Figure 35 shows the PRBS being filled using the MRS-D.

Figure 34. Using the Mini Robotic Submersible–Dredge (MRS-D) to fill the PRBS.

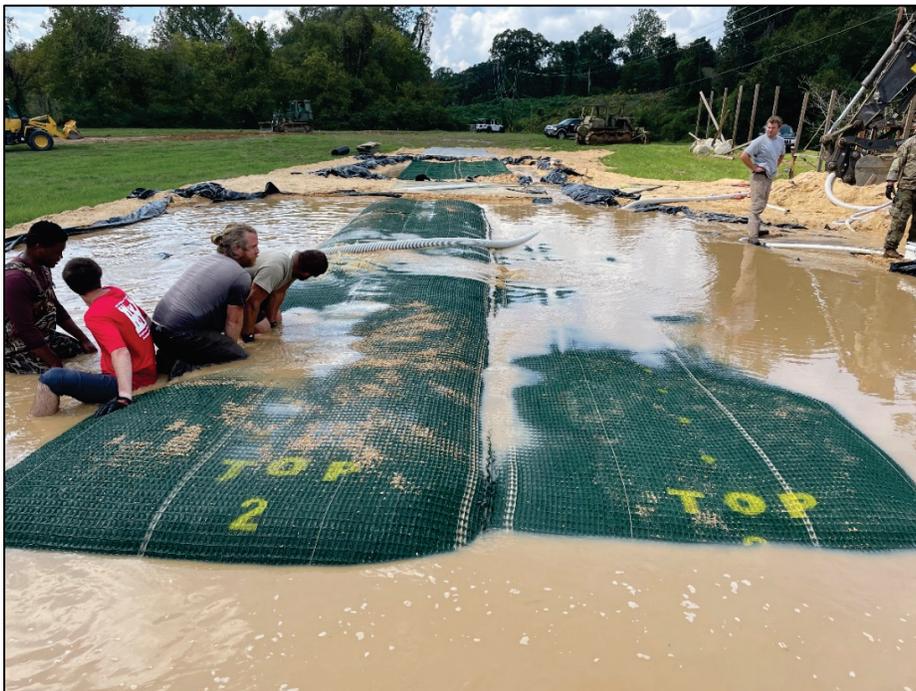
Figure 35. Continuing to fill the PRBS using the MRS-D.

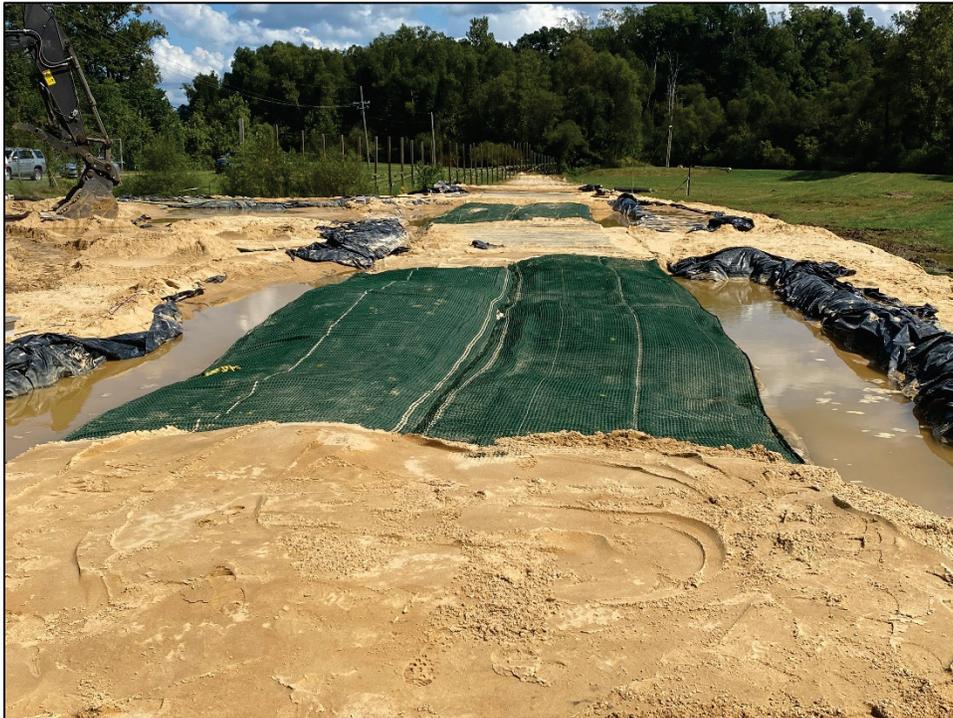
Fast Flow Pumps, LLC, resurfaced with the smaller dredge pumps. As a result, the research team settled on implementing fine sand free of aggregates, mixed with water in a metal tub and fed into a 2 in. diesel dredge pump. This set up worked well, and within several hours, the PRBS mats were made sufficiently flat for the pretraffic scans to be made and trafficking to begin. The fully filled PRBS mats are shown in Figure 36.

Figure 36. Completed test section prior to traffic application.

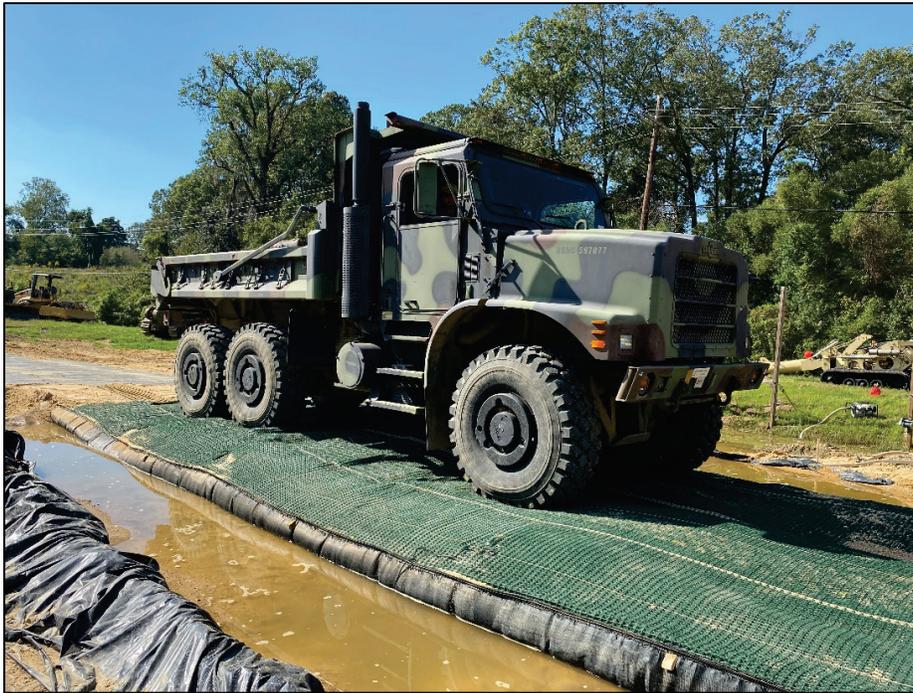
In this study, a dump truck variant of the MTRV was utilized to apply traffic, as shown in Figure 37. The truck was loaded with 7 tons of uniformly distributed lead blocks. The tire pressures were set following the recommendations for cross-country driving conditions (i.e., 28 psi in the two front tires and 35 psi in the four rear tires). The front axle of the loaded truck carried a load of 15,490 lbf, and the combined load on the two rear axles was 29,450 lbf. The contact area of the tire-to-soil was estimated assuming the contact pressure is equal to the air pressure of the tires, giving a front and rear contact area of 277 in.² and 210 in.², respectively. Usually, the actual contact pressure will be higher than the air pressure due to the rigidity of the tire sidewall. In previous studies using the MTRV, the contact pressures have been estimated to be approximately 28 to 32 psi for the front and 35 to 40 psi for the rear tires.

Figure 37. The MTRV trafficking over SUBMAT prototype and Airfield Matting 2 (AM2) transition ramps.

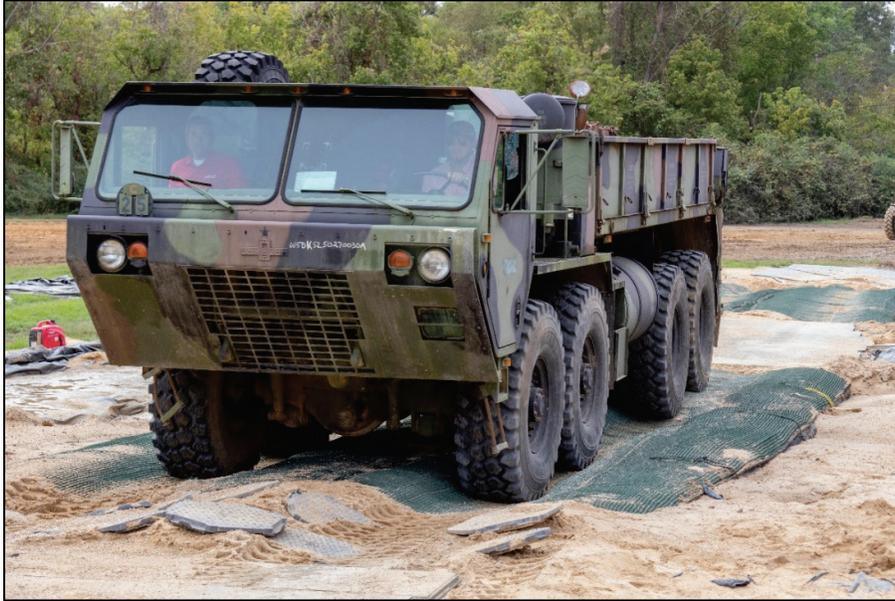
The HEMTT A4, as shown in Figure 38, is a four-axle heavy cargo truck with a nominal capacity of 10 tons used by the US Army. The front axle of the HEMTT was loaded to 13,700 lbf, the second axle to 14,140 lbf, the third axle to 16,240 lbf, and the rear axle to 15,660 lbf. Based on the axle loads and the tire pressure of 70 psi, the contact areas of the tires ranged from approximately 98 in.² to 116 in.² with an average of 107 in.². This agrees with the nominal tire pressure for a HEMTT of 70 psi with a contact area of 113 in.².

Figure 38. The HEMTT trafficking the test section.

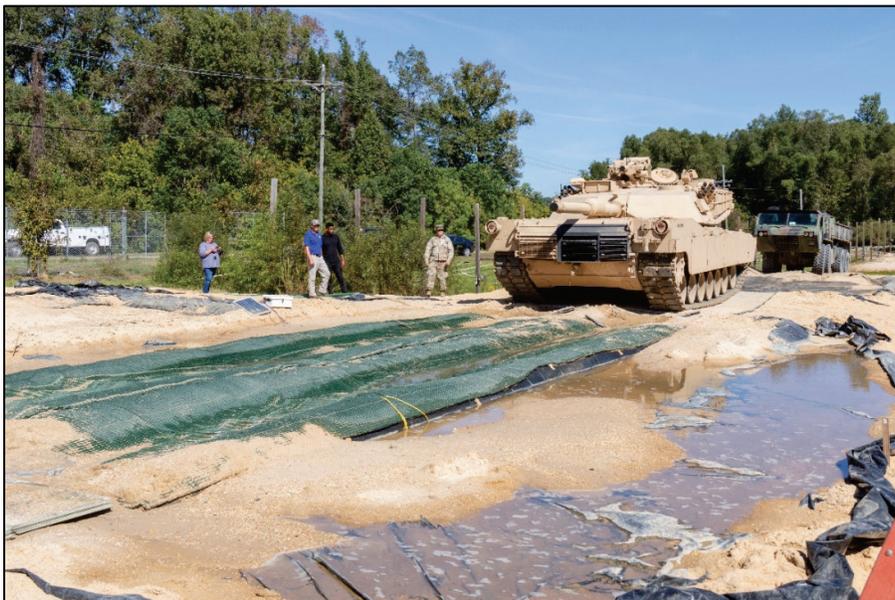
The M1A1 Abrams tank is an armored, tracked vehicle with a 120 mm cannon. The weight of the vehicle is nominally approximately 127,000 lbf but was not weighed at the time of testing. Its ground pressure is approximately 10 psi. This vehicle was used as a tracked vehicle for testing but was also equipped with road pads to protect paved surfaces. Figure 39 shows the M1A1 tank used in this study.

Figure 39. M1A1 Abrams tank trafficking onto test section.

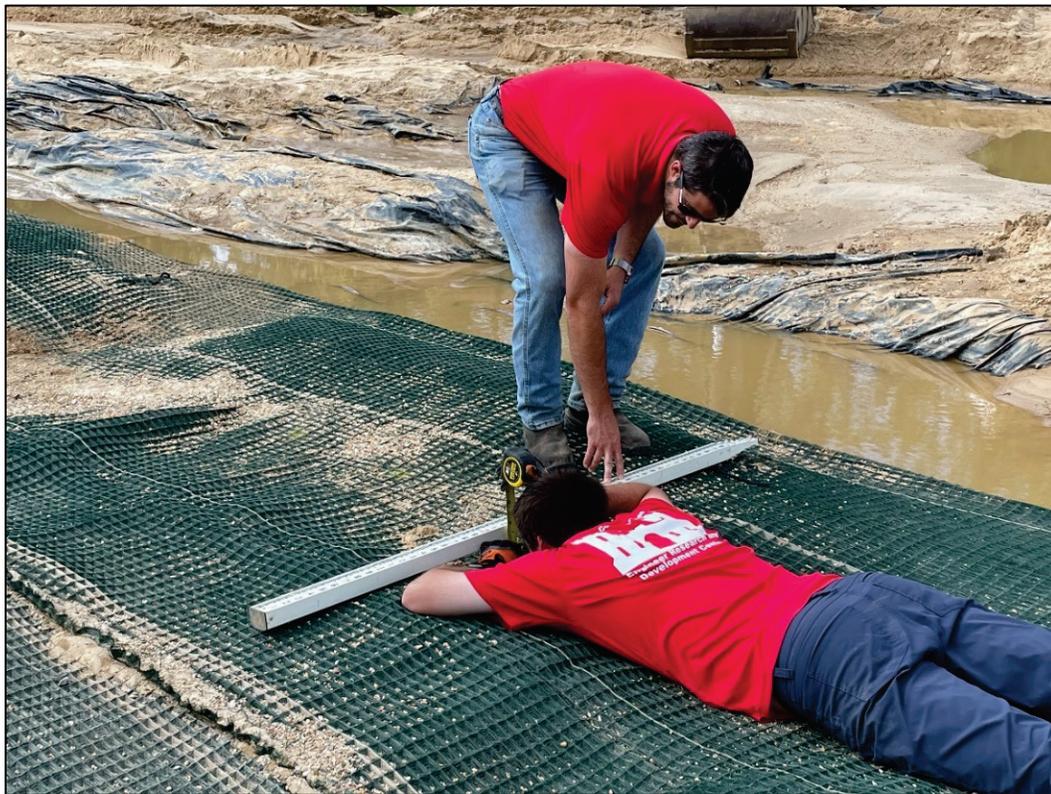
Rutting in the mats was quantified and recorded via lidar. A straightedge and a ruler were also implemented at the final pass of each vehicle to supplement and validate the lidar data. The rut depth was also measured via straight edge for the RGM system since the pit was flooded and lidar data could not be collected in a timely manner. Because the matting systems in this study were filled with sand and not rigid, the rut depth was measured without a weight applied. Typically, the weight is applied to depress the mat into the rut forming in the subgrade; however, all the mats in this study experienced the deformation and rutting within the mats themselves. A metal straight edge, 6 ft long, was laid across the north wheel path at the quarter points along the length. A rigid ruler was used to measure the distance from the straight edge to the center of the rut, 1 ft left of center and 1 ft right of center, as shown in Figure 40 and Figure 41. Rut-depth data are reported in Section 4.

Figure 40. Measuring rut depth with a straight edge.

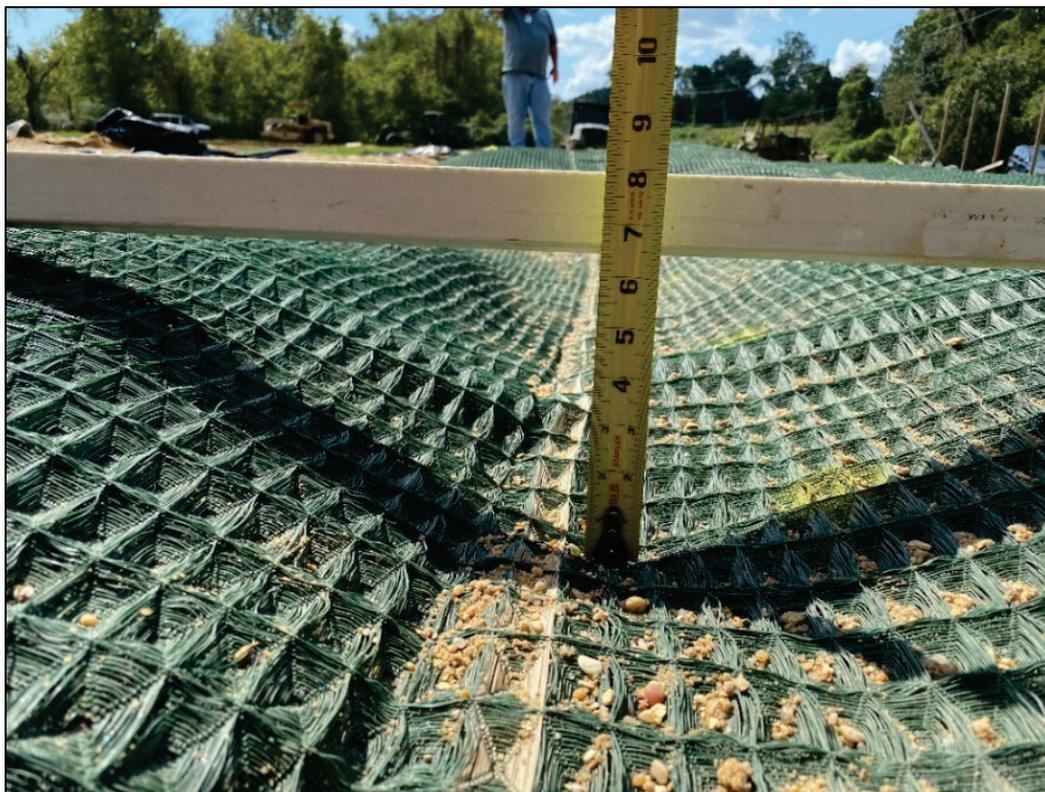
Figure 41. Rut-depth measurement from the north wheel path of PRBS 1 showing a 6.5 in. deep rut.

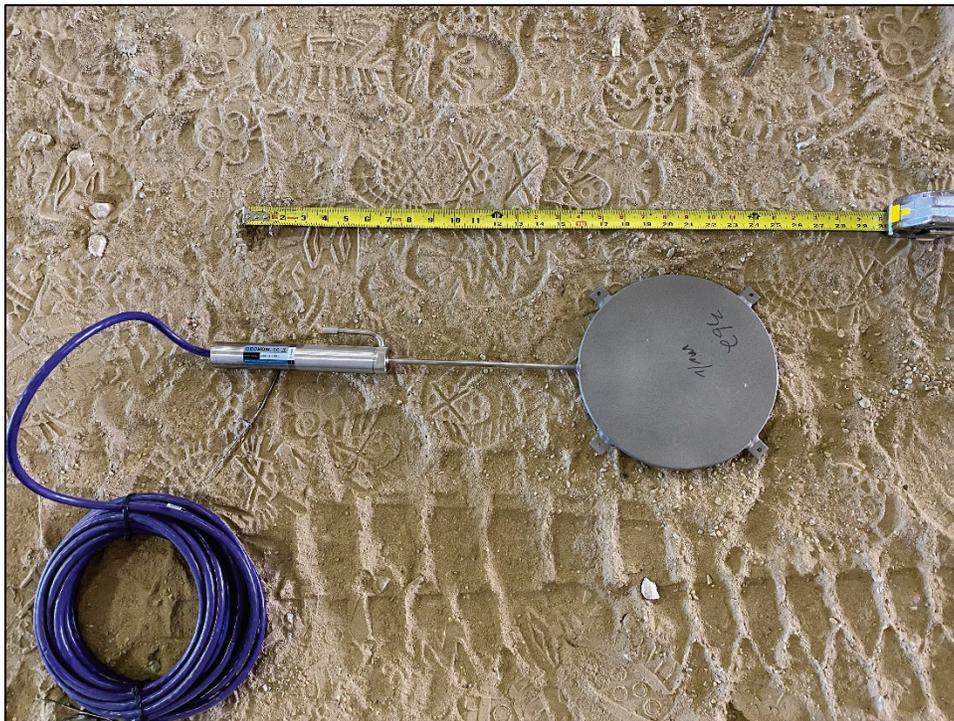
Figure 42. Earth pressure cell (EPC) to be buried 1 in. below the matting systems under the north wheel path.
