US TRANSCOM JDDE Program

Full-Scale Trafficability Testing of Prototype Submersible Matting Systems

October 2023

Final report

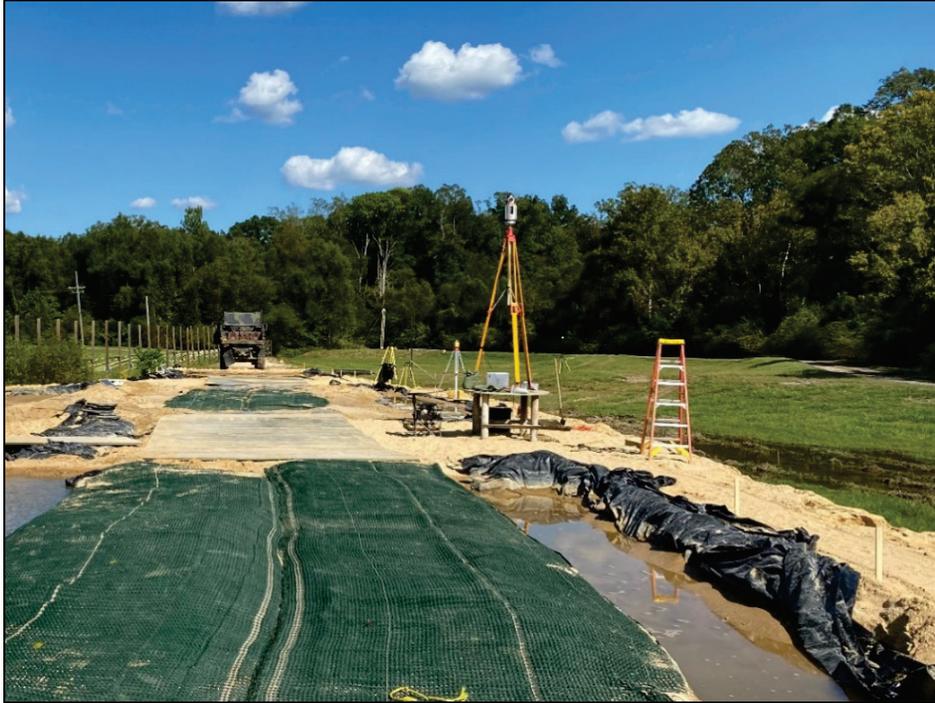
A Riegl VZ-400 (Riegl; Horn, Austria) terrestrial lidar scanner was used to capture the shape of the PYRACELL PRBS prototypes postfilling and pretrafficking, as shown in Figure 43 and Figure 44. Data were collected into pointclouds using RiSCAN PRO (Riegl, Horn; Austria) collection software. The Riegl VZ-400 is a line-of-sight instrument that is unable to penetrate water, which can cause shadowing behind steep slopes and missing data points in areas of standing water. Lidar scans were also collected throughout the trafficking tests after a predetermined number of passes to track the progression of rut depths for each test vehicle. Scans were collected after 5, 10, 25, 50, 200, 500, and 1,000 passes of the MTRV; 10, 20, 50, 100, 200, 250, 350 passes of the HEMTT; and 10, 30, 50, 100, and 150 passes of the M1A1. The first scan, taken after the deployment of the mats and prior to any traffic, is shown in Figure 45. These data are presented and discussed in Sections 3 and 4, respectively.

Figure 43. Lidar scanner mounted on tripod well above the trafficking lanes.

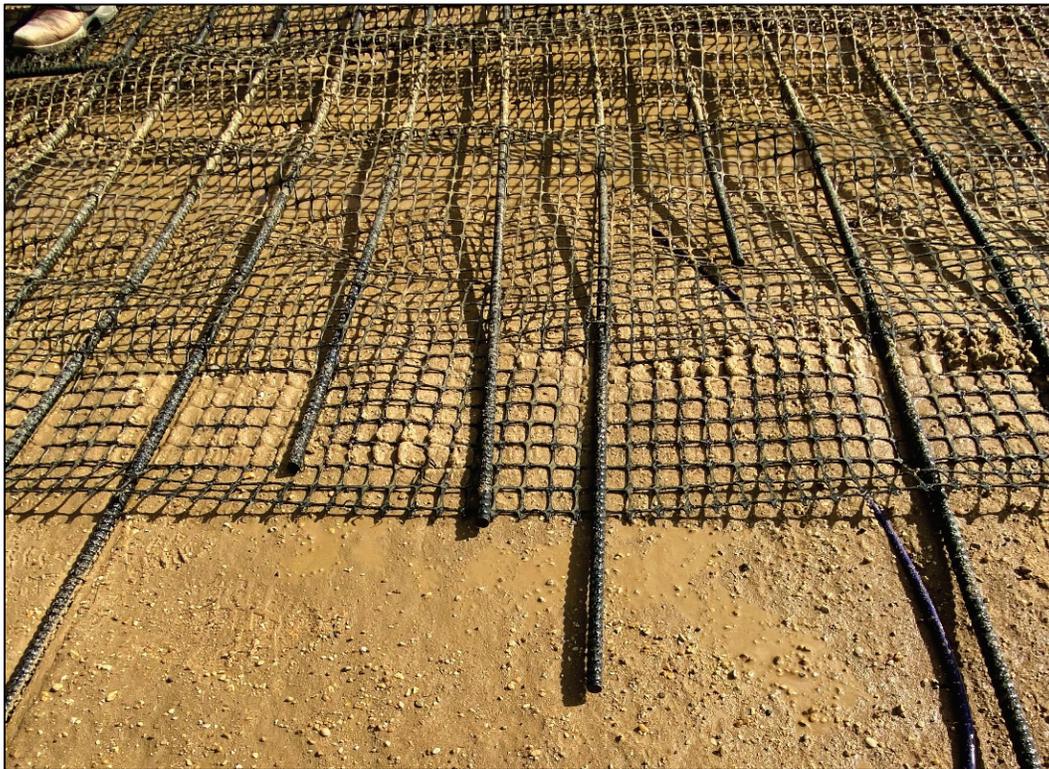
The basaltic rebar mat performed well for the initial traffic intervals under the MTRV. However, after 50 passes with the 7-ton truck, the basaltic rebar pieces were observed to be shifting laterally through the geogrid as shown in Figure 47. Also, four pieces of rebar were fractured. Trafficking continued on the rebar mat with several more fractured rebar pieces observed at each traffic interval. Finally, at 268 passes of the 7-ton MTRV, a chunk of rebar mat approximately 1.5 ft long and 4 ft wide got caught on the underside of the truck, ripping it out of the mat. Between the torn section of the rebar and the number of fractured basaltic rebar pieces, the mat was considered to have failed at 268 passes. The damage that caused failure is shown in Figure 48.

Figure 47. RGM with rebar reinforcement shifting in the geogrid mat as trafficking progressed.

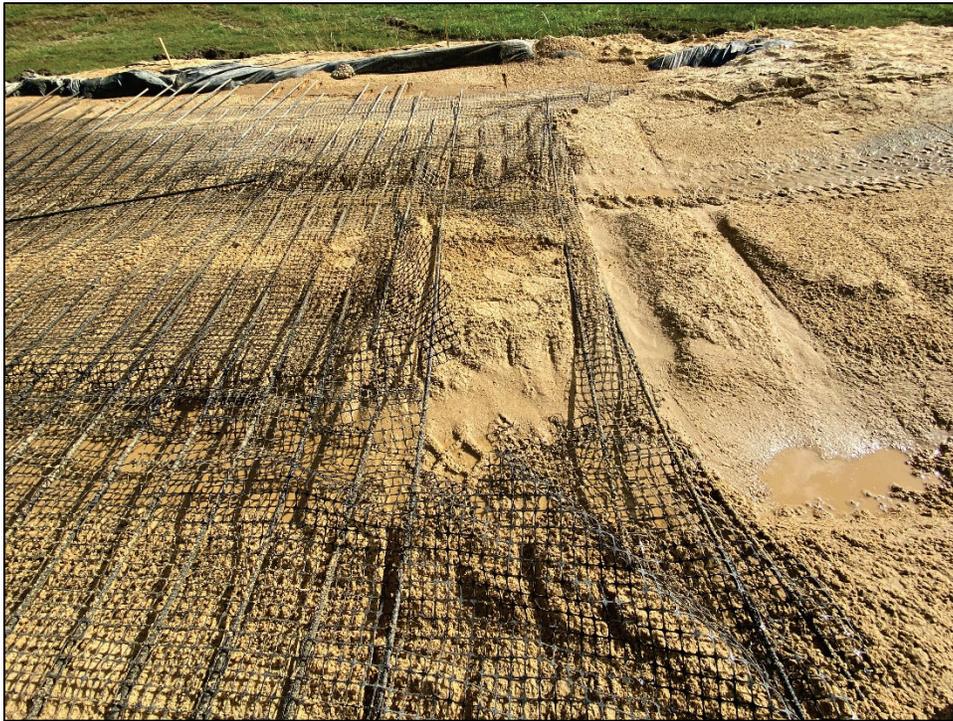
Figure 48. Final failure of RGM when a sizeable piece of the mat was ripped away by the MTRV.

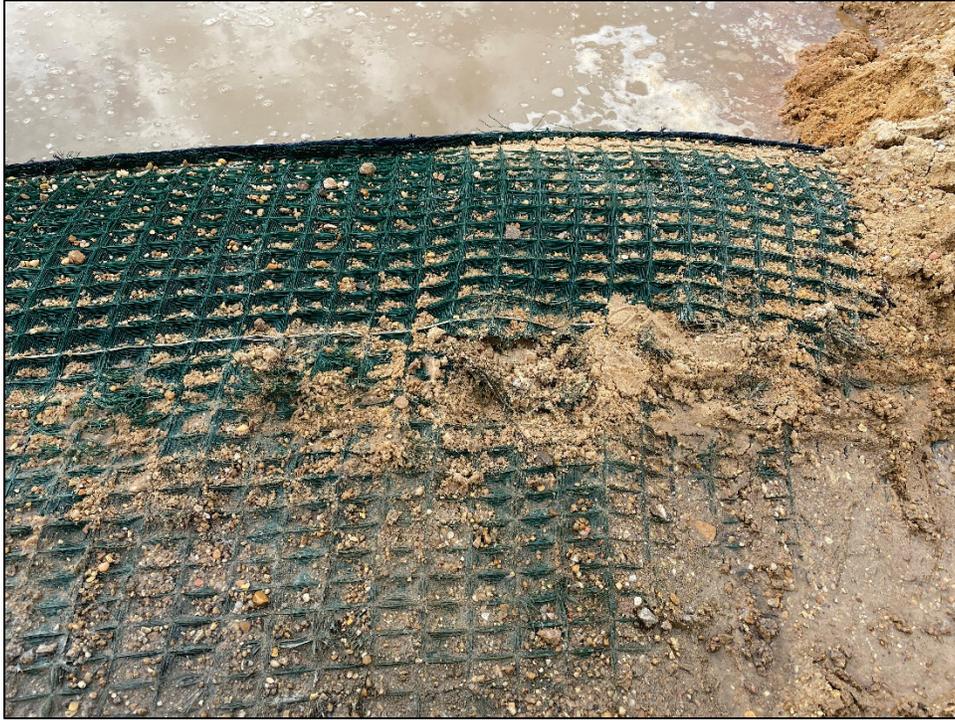
Figure 49. Damage to the PRBS from the M1A1 near the transition ramp.

The PRBS mat system prototypes performed well under the applied traffic. The wearing surface of the mats held up with negligible observable damage throughout the trafficking of each the 1,000 passes of the 7-ton MTRV and the 350 passes of the 10-ton HEMTT. Rutting developed in each mat deep enough to reach the 3 in. criteria, but the wearing surface held up exceptionally well, and vehicle traffic was not hindered in any significant manner. The wearing surface also held up with some minor observable damage after 50 passes of the M1A1 Abrams tank. The observed damage was tearing along the outside of the track path near the transition ramps as shown in Figure 49. Figure 50 shows the area near the transition ramp on one of the PRBS mats after 150 passes of the M1A1. The tear in the matting is a little shorter than 3 ft long. Continued trafficking with the M1 Abrams tank resulted in further tearing in the locations where damage was already observed, but the damage was not significant enough to be considered failure by mat breakage.

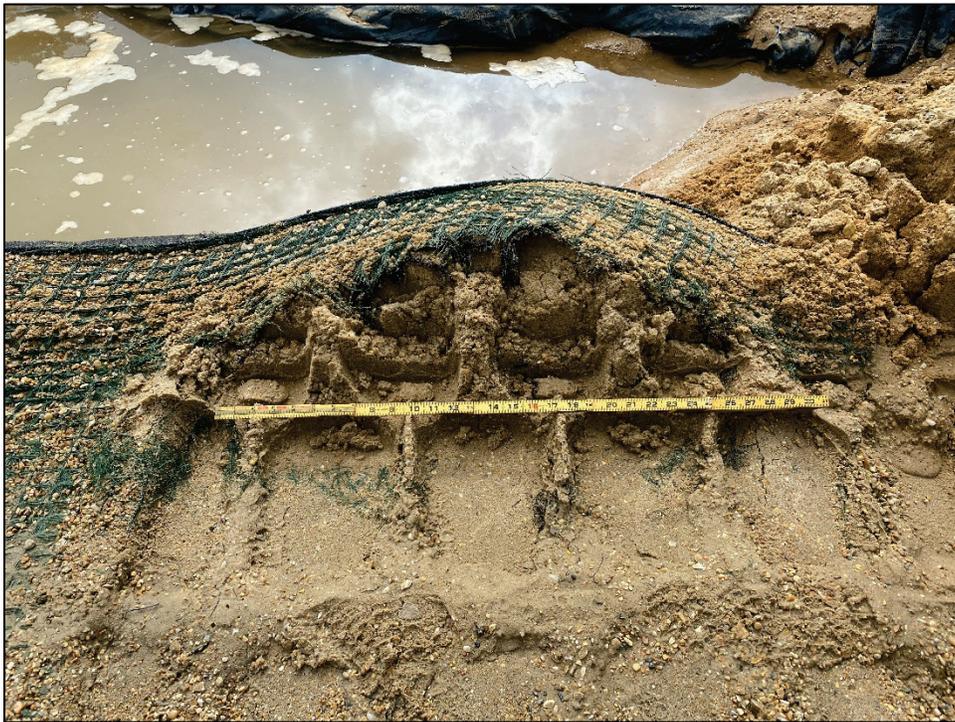
Figure 50. Total accumulation of damage near the transition ramps on PRBS mats after 150 passes of the M1A1 tank.

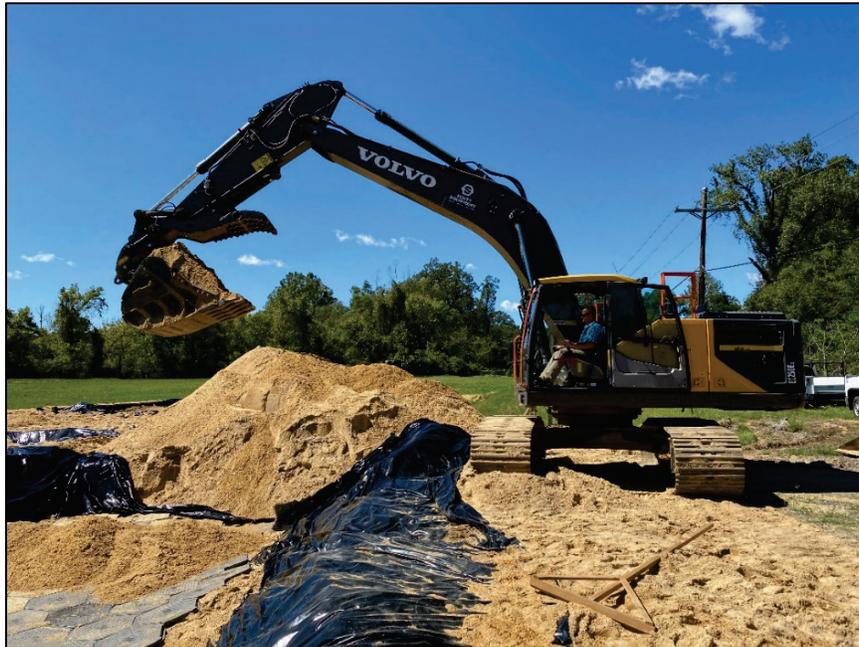
After completion of the MTRV, HEMTT, and M1A1 tank traffic, the PRBS mat system exhibited only minor damage. Therefore, the team decided to traffic the excavator on site on the mat. The excavator is shown in Figure 51. The goal of the additional traffic was to evaluate the effect of tracked vehicle traffic without any protective pads (recall the M1A1 had protective road pads on the tracks). After 26 passes of the excavator, only minor tearing of the wearing surface was observed with no major structural damage to the confining geosynthetic material underneath the wearing surface. The research team then decided to use a nearby D8 bulldozer (Figure 52 and Figure 53) with more aggressive tracks to gain better traction. Some significant damage was observed after 24 passes in which the tracks gouged slits through the geosynthetic material and began to tear the wearing surface completely away in other locations. Some of the preliminary damage can be seen in Figure 54. With the slits in the geosynthetic, the capability of the PRBS system to completely confine the sand material was compromised leading to degradation in performance, especially in a littoral environment. However, the damage was relatively small, so it is possible the matting system would be able to complete the mission with a limited number of passes of vehicles with tracks like the bulldozer, but the team recommends avoiding that type of vehicle tracks, if possible.

Figure 51. Excavator used to apply additional traffic on PRBS mats.

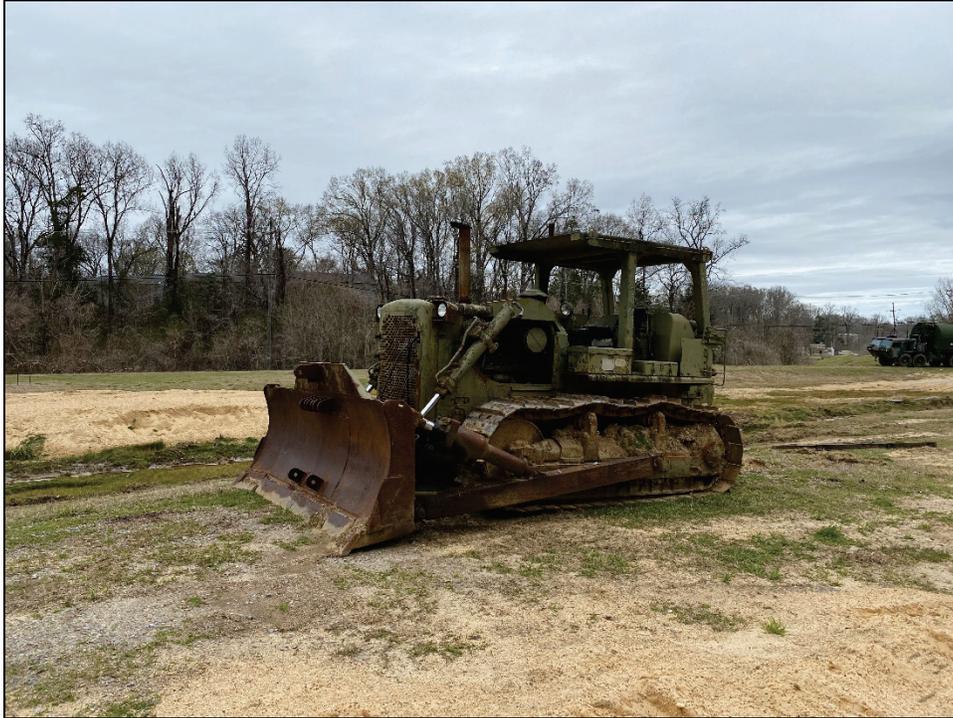
Figure 52. Army D8 bulldozer used for additional traffic on PRBS mats.

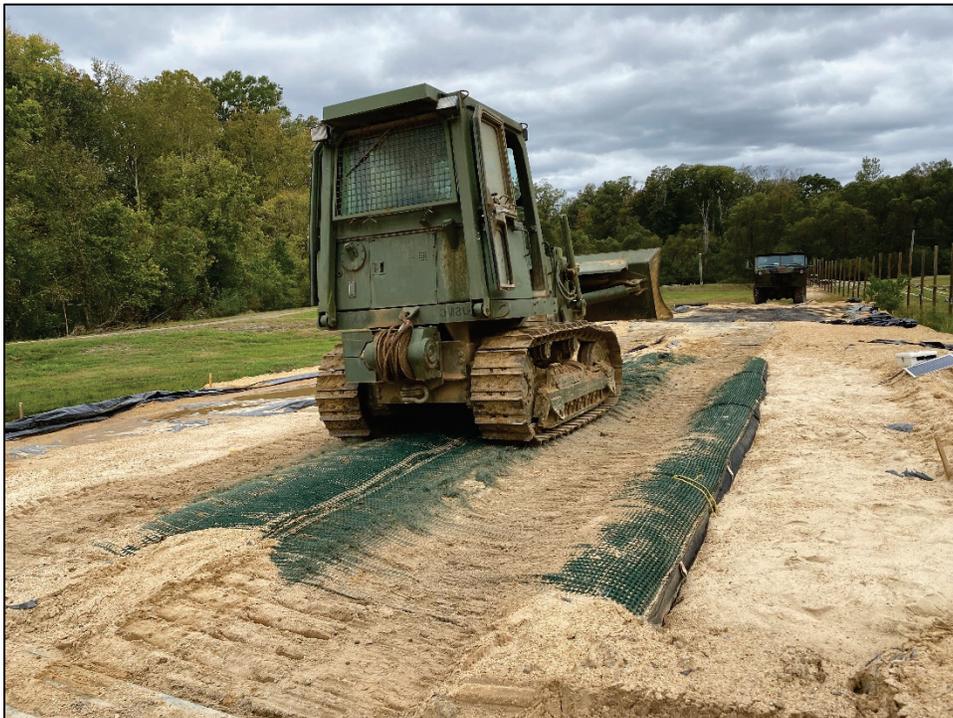
Figure 54. Damage accumulated from the additional traffic caused tearing in the wearing surface and punctured the geosynthetic material underneath.
